3. REMEDIAL ACTION PHASE WORK DESCRIPTION

3.1 Phytoremediation

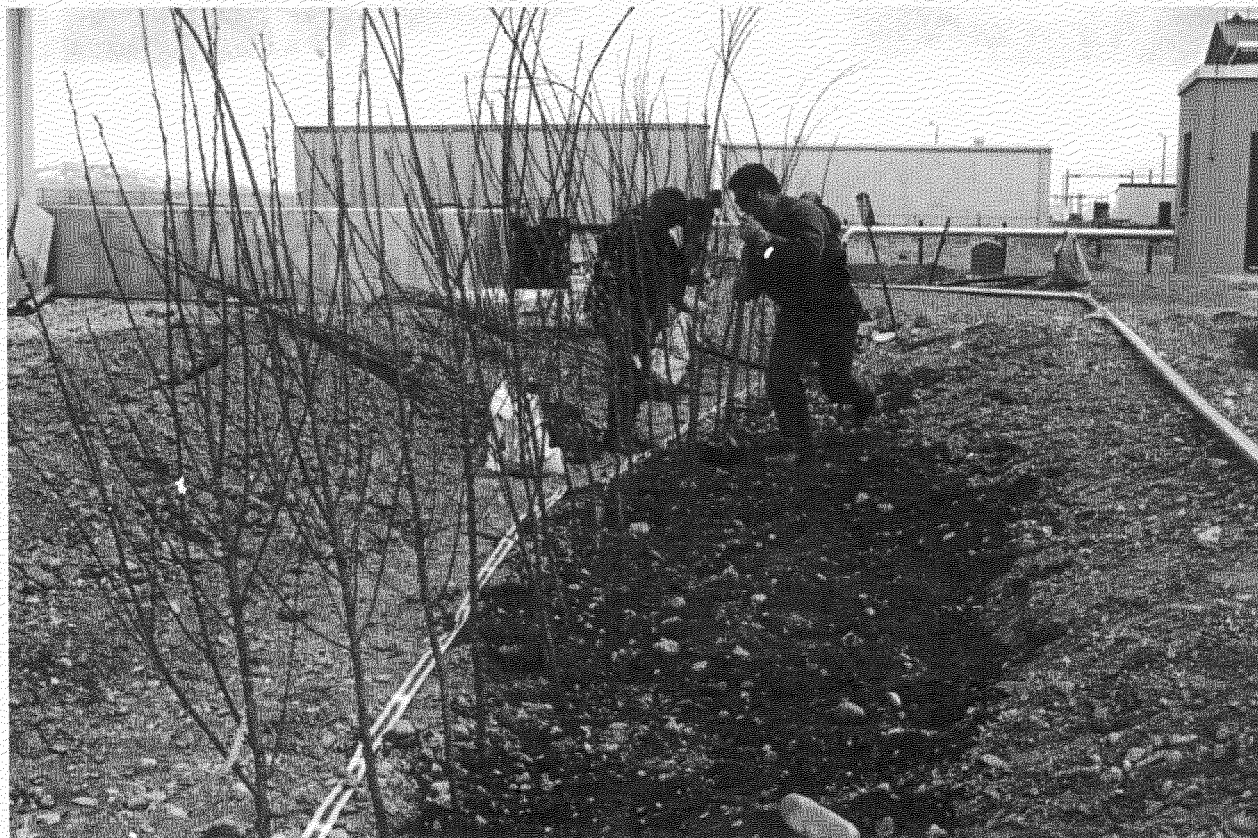
Figure 9. Planting of willows.

3.1.2.1 Inorganic Contaminants. Those sites that had inorganic contaminants (the west portion of the MCTBD and the IWLSD) were initially planted with 3-ft-tall, bare-root Prairie Cascade Willows (*Salix x pendula*). These trees were replaced with the hybrid poplar due to a shortage of willow trees in 2001. Trees were spaced approximately 18 in. on center to optimize the biomass of the plant at the end of the field season. The holes for the trees were either made manually using a spade or using a hydraulically driven auger mounted on a boom (see Figure 9). The holes were excavated to approximately 12 in. into the soil to allow for complete planting of the roots. The soils were placed back into the hole and lightly tamped. The trees were watered to allow for settling of soil around the roots and to reduce the amount of void space. Where the tractor was not able to reach a planting location, the willow trees were manually planted using a shovel to dig the hole.

When subsurface rock was encountered, the hole location was moved toward the center of the ditch. The center of the ditch contained the contamination; keeping the plants closest to the ditch center maximized the potential for contaminant removal. It was important to try to complete the planting as close as possible to the grid to limit the potential for stunting plant growth, which would reduce the biomass produced, and ultimately, contaminant removal.

At several grid locations the underlying basalt layer restricted the planting depth to less than the required depth of 12 in. Trees were planted at these shallow locations only if a depth of 6 in. could be reached; in these cases, a larger diameter hole was required to accommodate the root ball. If a planting depth of 6 in. could not be reached, the location was bypassed for the next grid location.

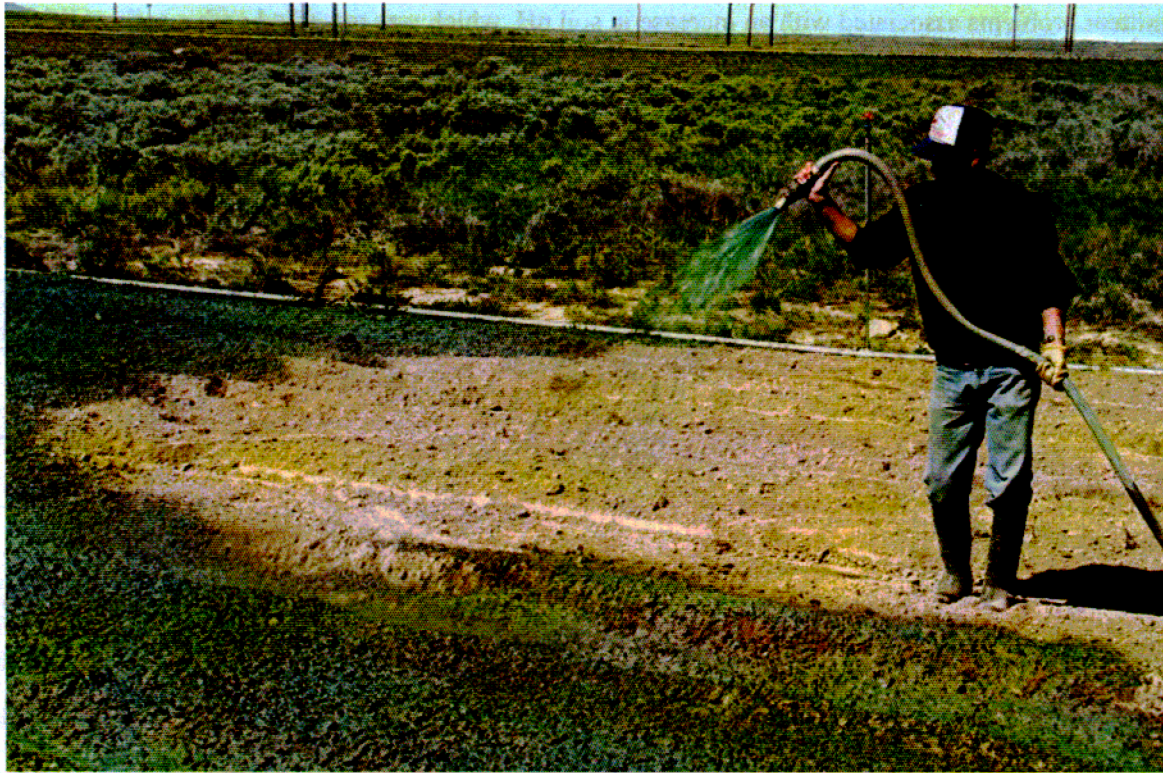
Figure 10. Application of kochia seeds via hydroseeding.

Seeds were planted the first field season using a hydroseeding truck equipped with a tackifier to distribute the seeds in a paper-mulch/water/fertilizer mixture (see Figure 10). This method of seeding proved problematic as the paper-mulch formed a hard crust once dried, which inhibited the emergence of the kochia sprout. During the second field season, kochia seeds were broadcast by hand with much improved results. The kochia seeds were able to sprout faster, which allowed for harvesting twice in one season. The successful increase in biomass production observed in the second field season was mirrored in the third and fourth field seasons when seeds were similarly hand broadcast. In each field season where

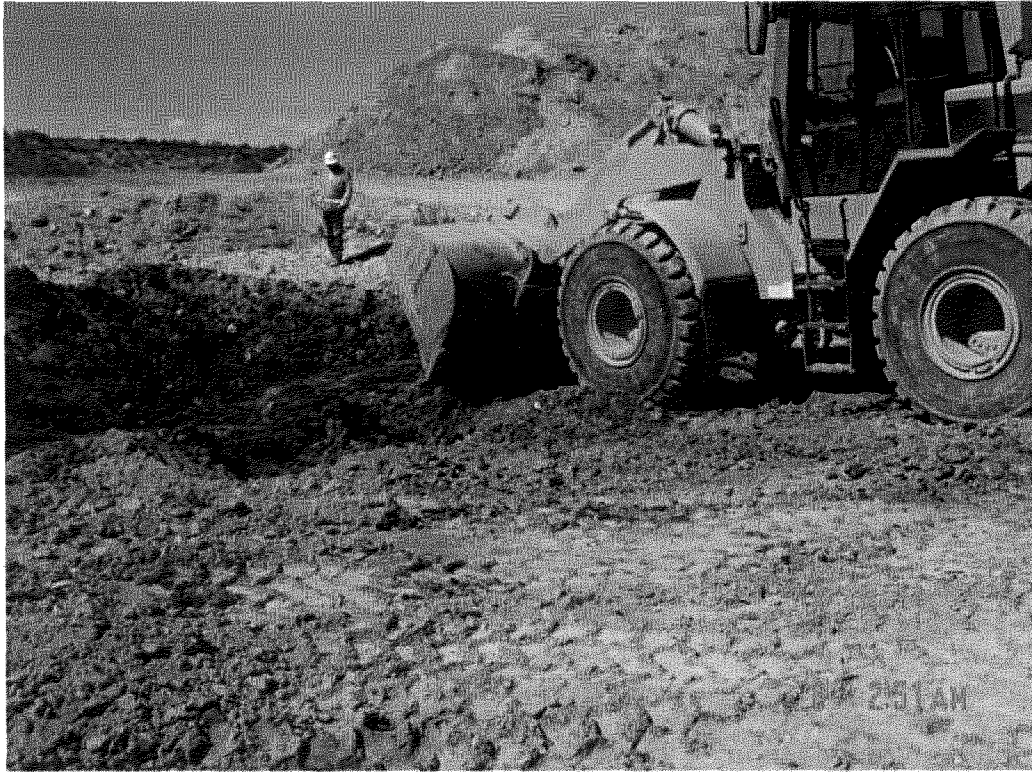
Figure 16. Excavation activities at the Industrial Waste Pond.

The excavation of soil was conducted using a front-end loader and dump truck. A laborer assisted the front-end loader operator in the use and control of the bucket (see Figure 16). The excavated material was placed in the dump truck stationed on the road just west of the ditch. This process was repeated until the front-end loader had excavated as much soil as possible from the contaminated ditch. The laborers then used shovels to manually remove the remaining soils in the ditch and place them in the front-end-loader bucket. The laborers then used shovels and brooms to remove as much soil as possible from the top of basalt in the ditch bottom.

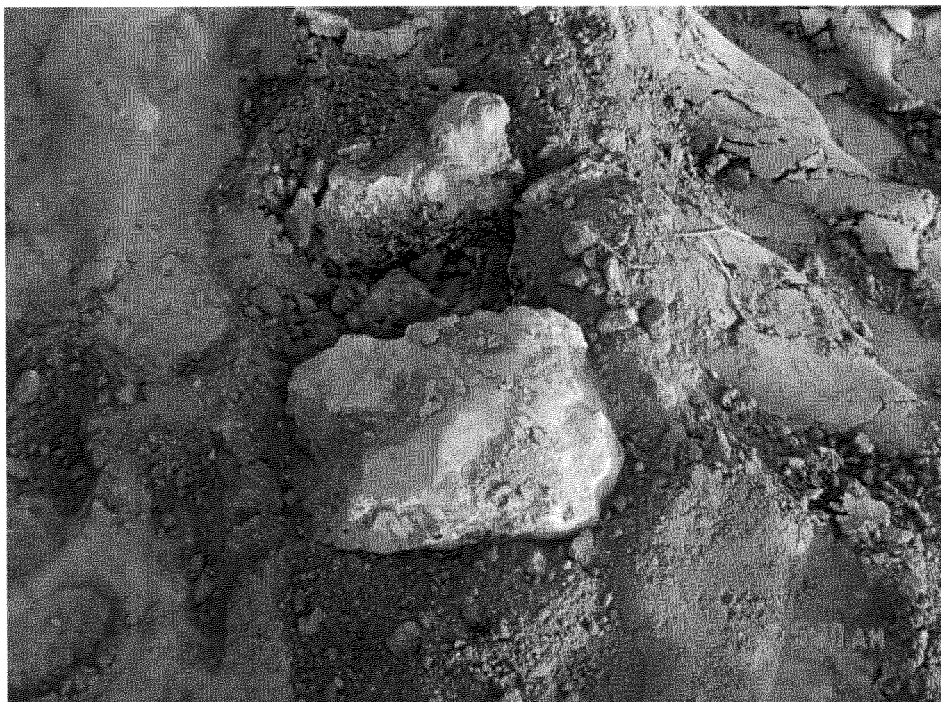
Figure 17. Underlying basalt layer.

In November 2004, following the removal of contaminated soil to the exposed bedrock to meet the RGs, each site was regraded. Clean backfill material was trucked from the borrow pit located 2 miles northwest of the MFC. The backfill material was applied in approximately 4-in.-deep lifts, and compacted using the tires and weight of the front-end loader and gas-powered hand tampers around the culverts. A scraper was utilized to blade the bottom and side-slopes of the ditch to its original shape.
